## The Maine Maritime Steel Phase Apparatus – a New Design for Materials Lab Courses

### Steel Metallurgy and Strength of Shipbuilding Materials

J. Schoof and P. Wlodkowski  
Maine Maritime Academy, October 18, 2014  
for Maritime Education Summit

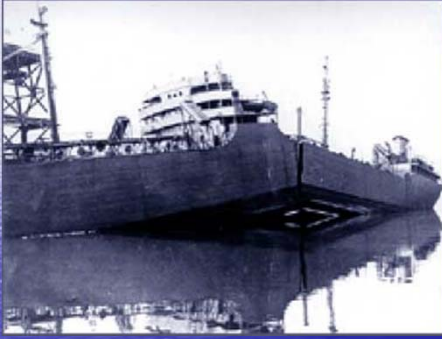
Cargo vessel (DWT 11000 Liberty Ship) (T-2 tanker)

- 152m long T2 tanker 'Schenectady'
- January 1943
- In the builder's yard in Portland, Oregon
- A few days after completing sea trials
- While lying at the outfitting dock
- Suddenly broke in two
- **Conditions:**
  - water temperature 4°C
  - no waves / calm
  - air temperature -3°C
  - winds light

- Failure was sudden - loud bang heard a mile away
- Fracture extended through the deck, the sides of the hull, the longitudinal bulkheads and the bottom girders
- The vessel jack-knifed, hinging on the intact bottom plate
- The central part of the ship rose clear of the water so no flooding of the hull through the fracture occurred

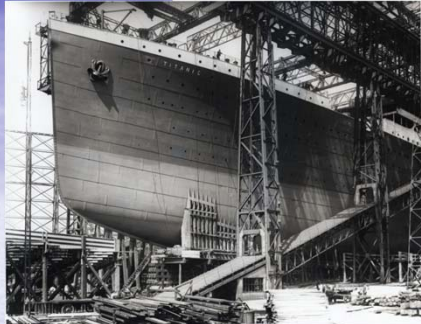
Bow of the Titanic under construction – from a private collection of photos by one of the shipyard workers – the riveted plates show clearly.

- 1997 - Dr. Tim Foecke analyzed the metallurgy of salvaged rivets
  - He found about three times more slag than in modern wrought iron
    - Slag is a glassy residue of smelting
    - Can make rivets brittle and prone to fracture
- Many of the rivets recovered from the Titanic contained high concentrations of slag.

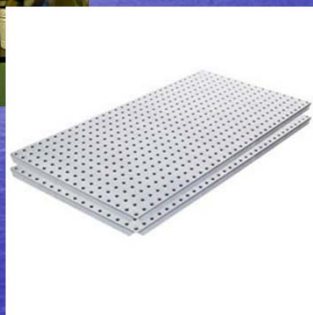
## The Maine Maritime Steel Phase Apparatus – Design Materials to buy – Alligatorboard

- Alligatorboard is metal pegboard
- Easy to mount lab demos
- Wires are behind the board
- Mounted on threaded shafts with wing nuts – easy to remove for repairs
- Buy two sheets of white Alligator board, with turned edges 16" x 32" (\$40)
- [www.alligatorboard.com](http://www.alligatorboard.com)

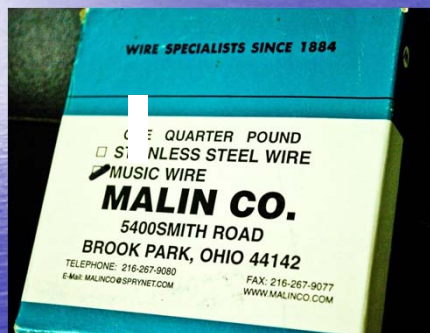
### The Maine Maritime Steel Phase Apparatus – Design Materials to buy – steel wire

- From McMaster Carr
- 1080 Steel Music Wire, \$4 for ¼ pound coil, approx. 100 feet
- Diameter is 0.029"
- <http://www.mcmaster.com/>

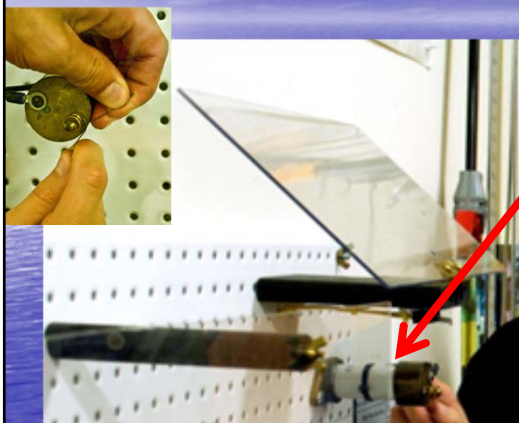
### The Maine Maritime Steel Phase Apparatus – Design Materials to buy – ceramic standoffs

- Ceramic standoffs – purchased as navy surplus for \$9 each – need to be sturdy and to provide screws for electrical connections to wire – I bought three to have a spare
- Hanging in background is a magnet with a 2' insulated handle – made in lab – also a homemade plastic grabber with sponges fitted to it for safe quenching

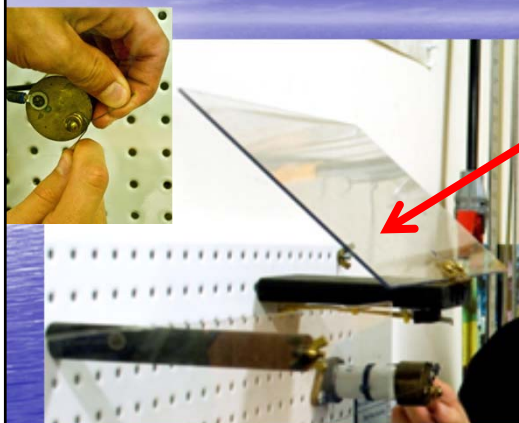
### The Maine Maritime Steel Phase Apparatus – Design Materials to buy – Lexan panels and mounts

- Lexan panels purchased from McMaster and cut in shop – cover entire length of wire with access door at right end
- Hinges from hardware store
- Supports are dowels cut in shop and fitted with wingnuts and threaded shafts both ends – stained black

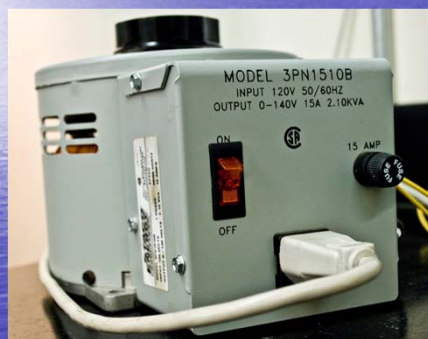
### Materials to buy: Autotransformer (Variac)

- Need 15A model
- Staco Model #3PN1510B
- Approx. \$750

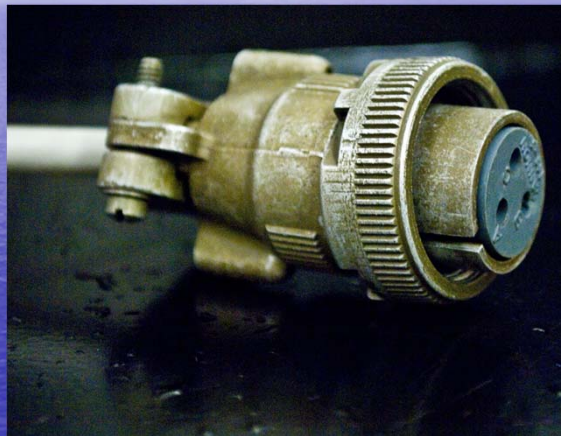
Safety – removable power plug  
stored when apparatus is not in use

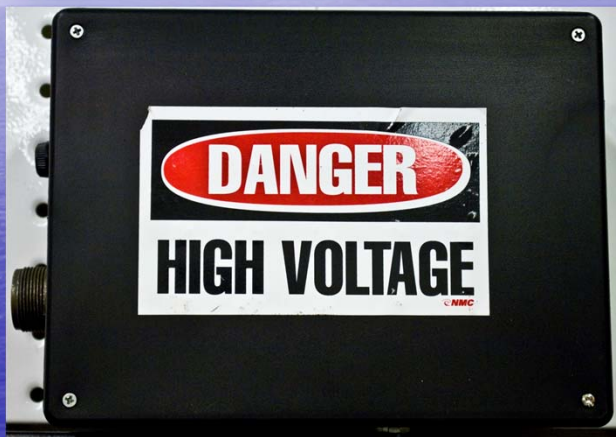
Electrical connections box  
Contains terminal block for AC and relay for interlock

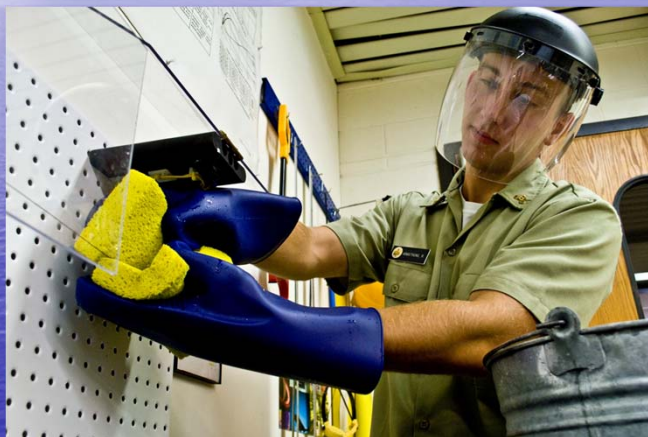
Safety features  
Silicon electrical safety gloves  
Power is off

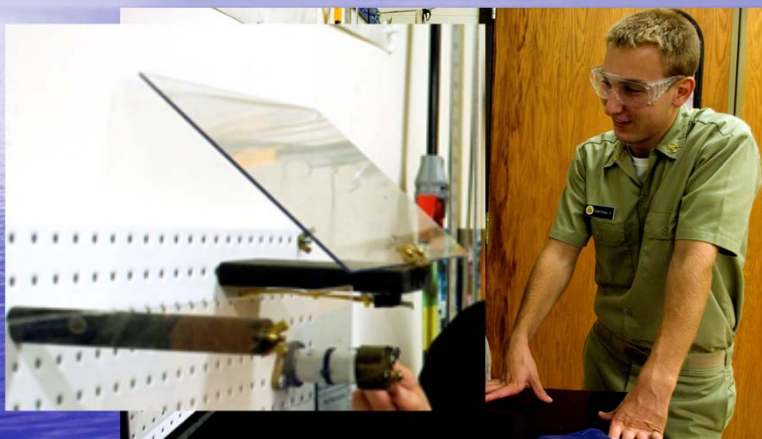
Replacing the wire  
You will need very good cutters – length is 5 feet

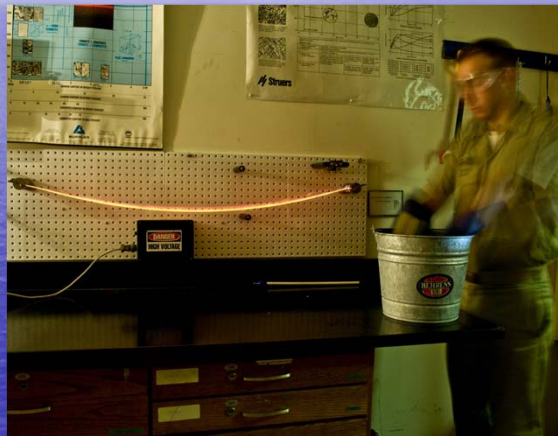
## Preparing to quench – you will need a bucket and sponges

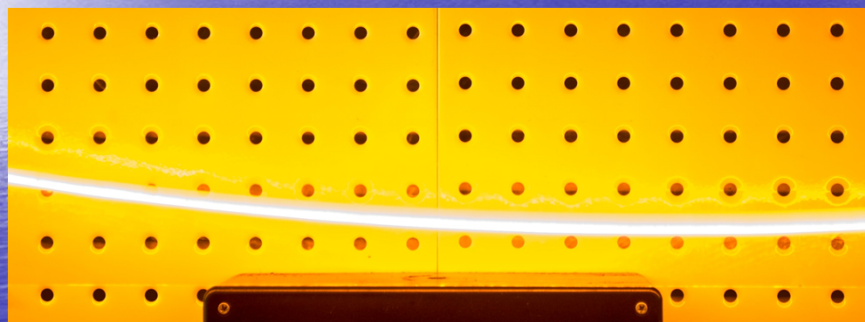
Wire under power  
Notice the sag as steel becomes ductile

- We often tensile test a steel sample first to see how much force it takes for the steel to break at room temperature
- We then heat treat a 1080 steel using the MMA Steel Phase Apparatus and look at the effect of the crystal structure changes
  - It becomes ductile when heated – sags several degrees
  - Carbon is diffused from the wire as it heats
  - If quenched when still above 740C it will change from a strong, ductile steel to a very brittle steel
  - Magnetism is interesting to observe as the steel is heated

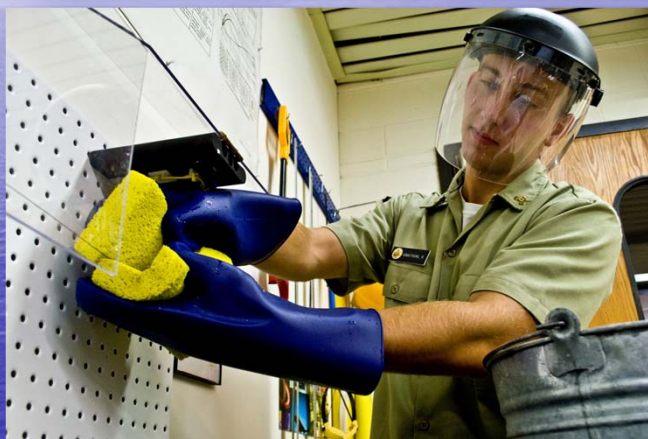
Quenching the wire  
(Power is off)

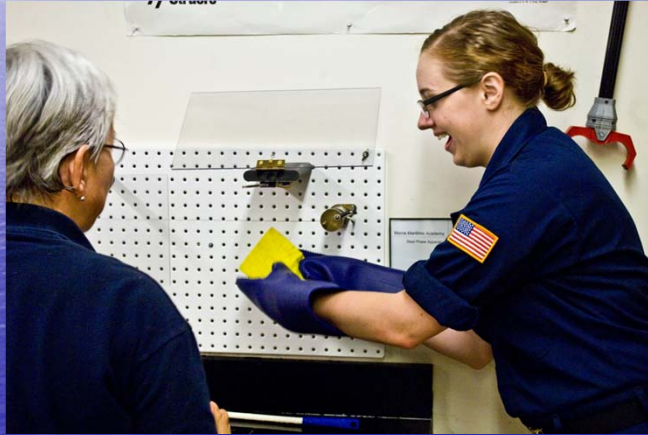
## Quenching the wire Speed counts

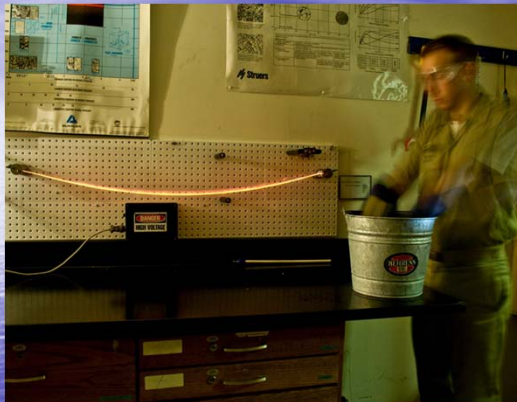
## Lab Demonstration Heat Treated Steel
